National Dam Safety Program. Tipton Dam (NDI I.D.-525), Susquehanna River Basin, Tipton Run, Blair County, Pennsylvania. Phase I Inspection Report.

TIPTON DAM

NDI I.D. NO: 525

PHASE I INSPECTION REPORT NATIONAL DAM INSPECTION PROGRAM

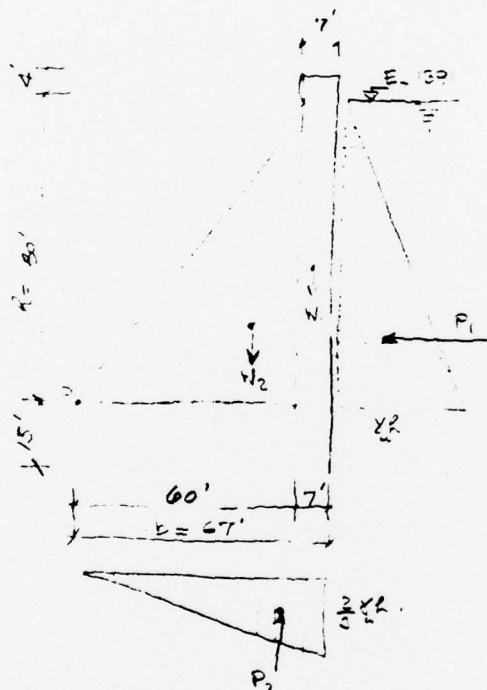
STABILITY OF DAM @ NORMAL P.O.O. LEVEL.

OVERTURNING MOMENTS ABOUT P.T. 2

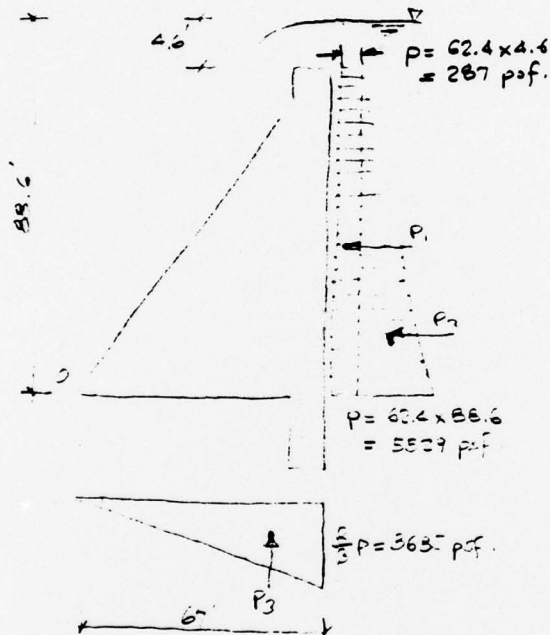
STABILITY OF DAM @ POOL 4.6 ABOVE CREST

WATER PRESSURE

$$P_1 = 62.4 \times 4.6 \times 84 = 24 \times 10^3 \text{ lb.}$$
